Using Sea Turtle Carcasses to Assess the Conservation Potential of a Turtle Excluder Dredge

Abstract.—Fisheries observers have documented interactions between sea turtles in the family Cheloniidae and the Atlantic sea scallop *Placopecten magellanicus* fishery. Sea turtle injuries resulting from interactions with scallop dredges are being mitigated through shifts in fishing effort and modifications to fishing gear. The standard New Bedford dredge can trap objects and crush them as they pass between the dredge frame and sea floor, so a modified turtle excluder dredge has been designed to reduce the likelihood of a turtle's passing under the frame when the dredge fishes on the seafloor. The key elements of the modified design are a forward cutting bar (which results in a sloping rather than a vertical face), a reduced number of bale support bars (just the center and outer bales), extension of the outer bale bars before tapering to the gooseneck (hauling point), and a reduction in the sources of entrapment between the depressor plate and the cutting bar via reduced spacing of struts. We evaluated the ability of the modified dredge to cause live sea turtles to pass over it by using lo

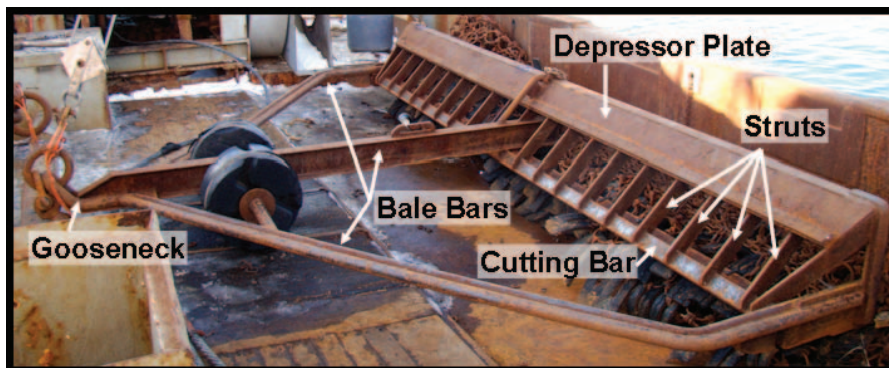
FIGURE 2.—Photograph of the Cfarm turtle excluder dredge.

After the 2006 loggerhead carcass tests, the prototype was further modified by removing the “turtle guards” from the cutting bar and extending the outside bale bar 50 cm from the main frame before they tapered toward the gooseneck (hauling point) to increase the escape opening between bale and frame. The result of this series of modifications is called the Cfarm turtle excluder dredge (Figure 2). Because the final Cfarm turtle excluder dredge design differed slightly from the 2006 prototype, additional carcass tests were per-

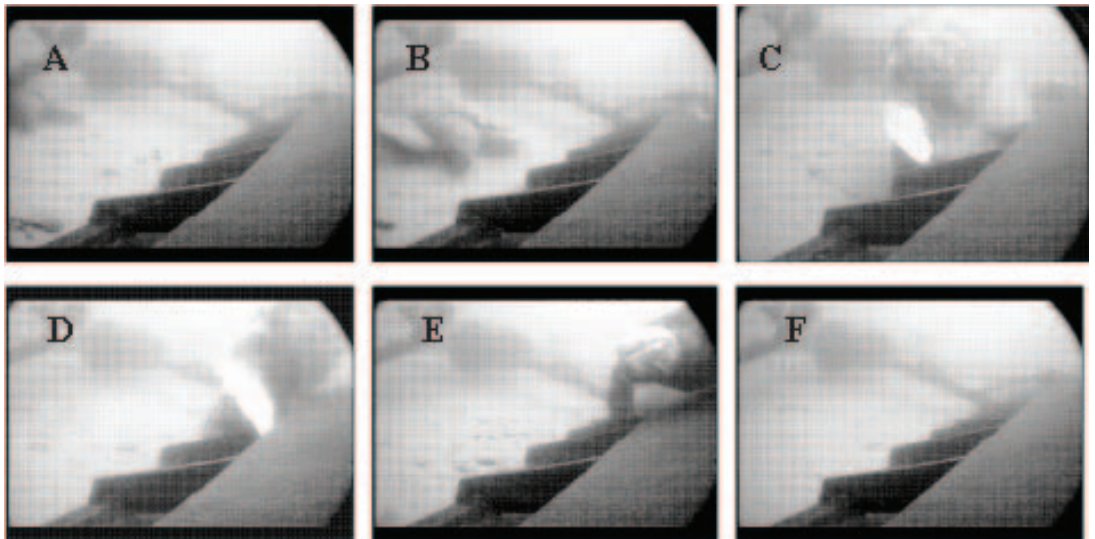
FIGURE 3.—Photographic sequence of a loggerhead sea turtle carcass encountering the Cfarm turtle excluder dredge: (A)–(B) the carcass first passes under the bale, then contacts the forward cutting bar, (C) gets deflected by the closely spaced struts, (D)–(E) is guided over the dredge frame, and (F) passes out of the view of the dredge-mounted video camera.

Nine interactions between a loggerhead carcass and the modified dredge were documented on the video recordings (Table 2; Figure 3). Two carcasses went over the dredge bale, while seven went underneath the bale. Two of the carcasses that went under the bale hit

the hard rubber bale wheels and were hung up for a few seconds before passing the bale (one over and one under) and going over the dredge frame. In all nine interactions, the carcasses hit the dredge at some point and passed over the dredge frame. When all five carcasses were examined for injuries, the only observed carcass damage was superficial scratches and chips (Figure 4). None of the damage observed on the five recovered carcasses was consistent with a category I or category II injury (NMFS 2004).
