# **Testing of a Sea Scallop Dredge Dual Mesh Size Twine Top For Bycatch Reduction**

## **Final Progress Report Prepared for the 2009 Sea Scallop Research Set-Aside**

**Ronald Smolowitz, Matt Weeks  
Coonamesett Farm Foundation, Inc**

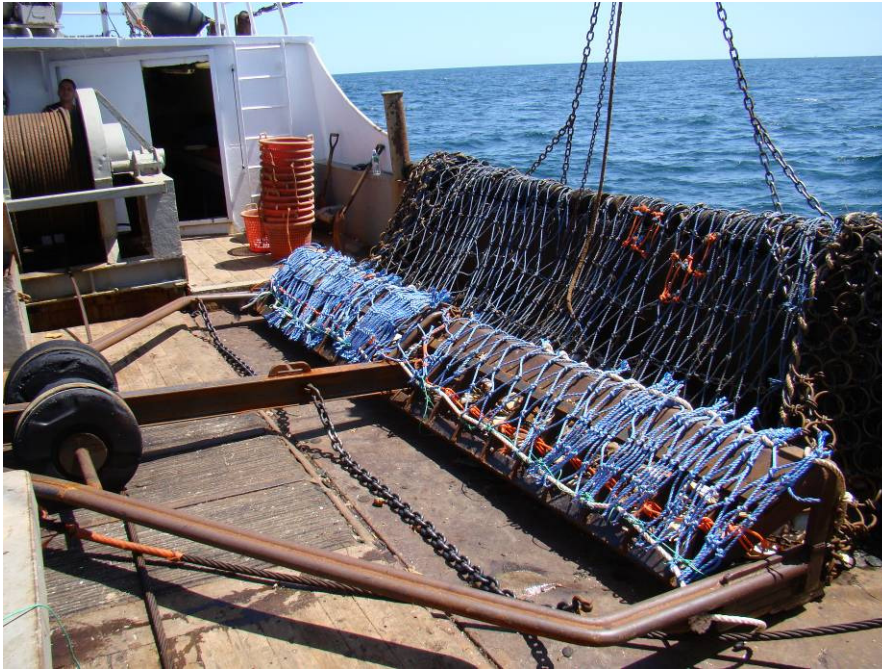
Table 6: Catch with a fish sweep of 5/8-inch chain added in front of the cutting bar.

Added Fish Sweep

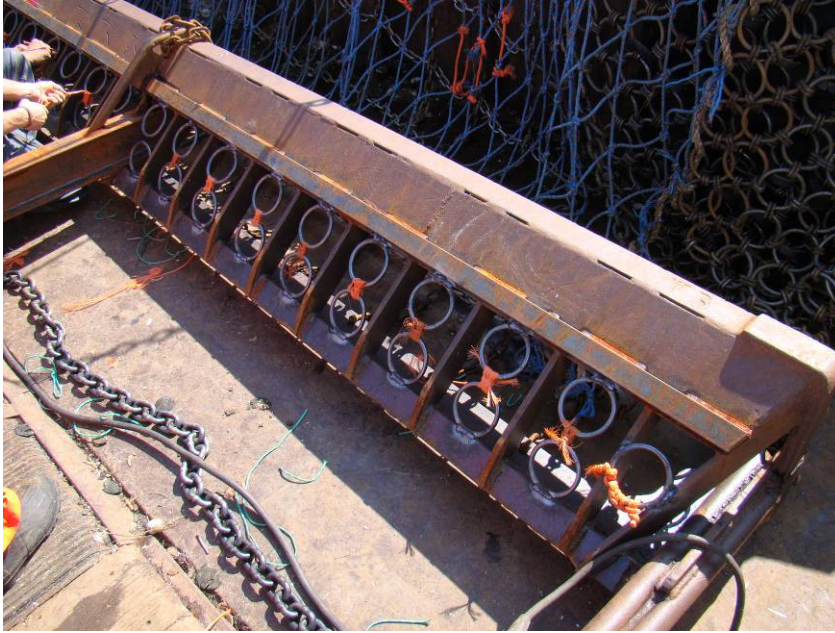
Table 8: Tows with ring blocking and no fish sweep.

Added Ring Blocking-Removed Fish Sweeps

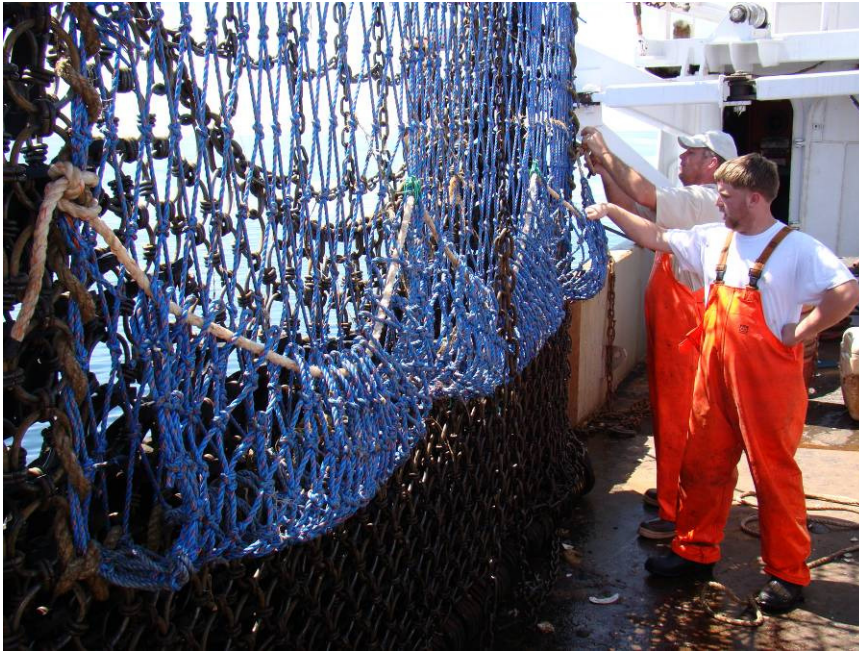
Table 12: Added three pockets using the 6-inch mesh over the 12-inch mesh.

Added 3 pockets of 6' mesh; kept ring blocking

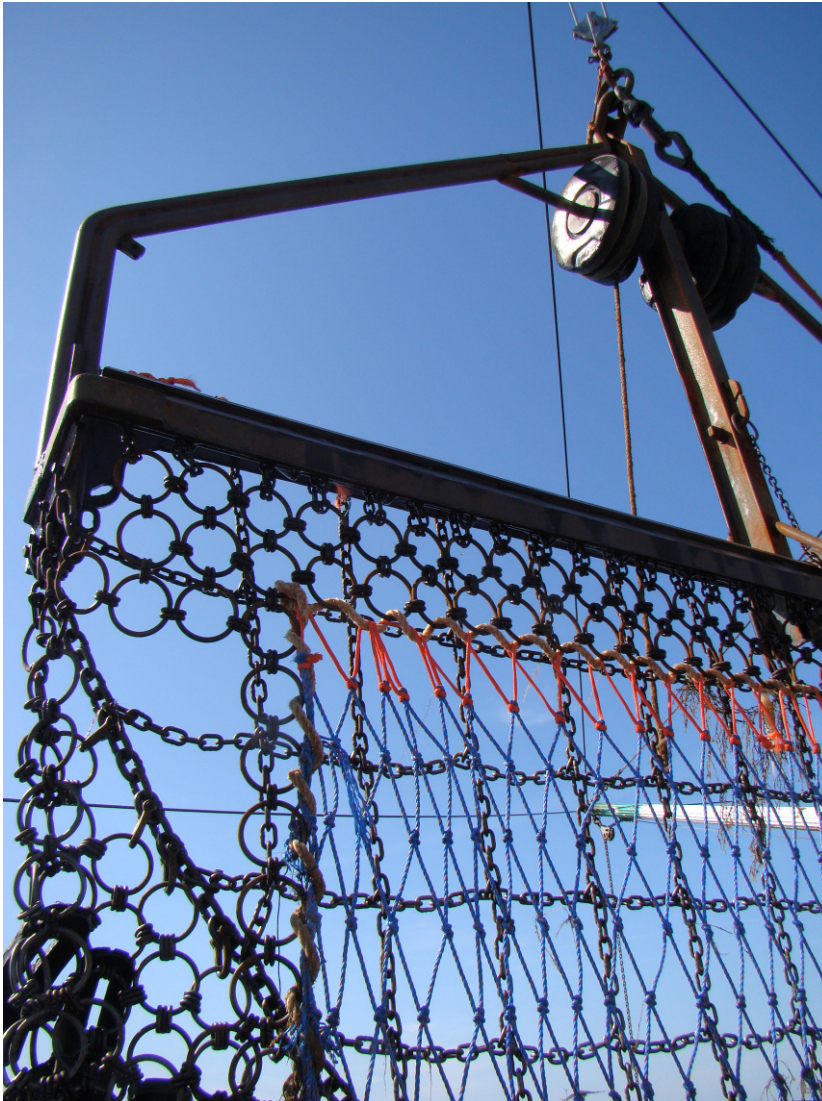
Table 13: Opened holes in the side panels

Opened Side panels

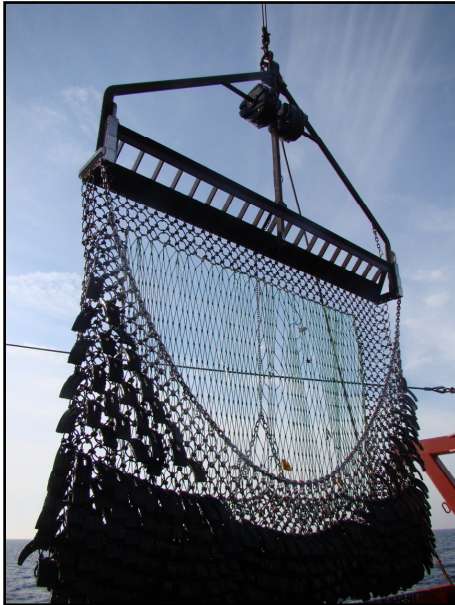
*Control Dredge*

Bag with 7 ring apron & 60 mesh twine top mesh twine top vs.

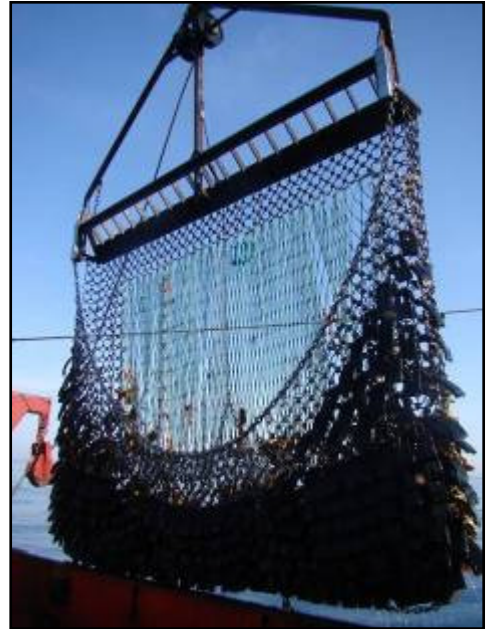
*Experimental Dredge*

Bag with 9 ring apron & 80 mesh twine top

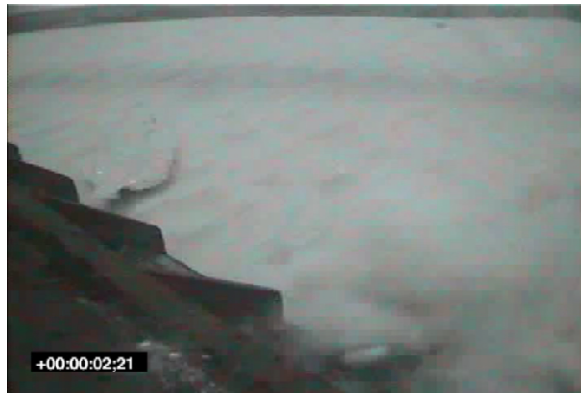
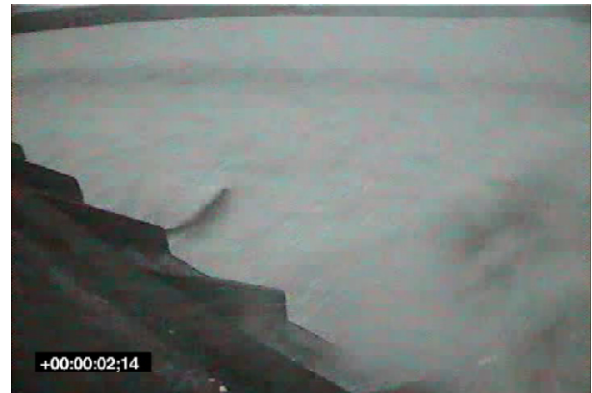
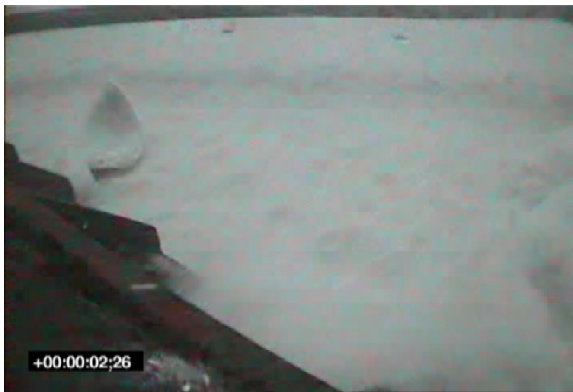
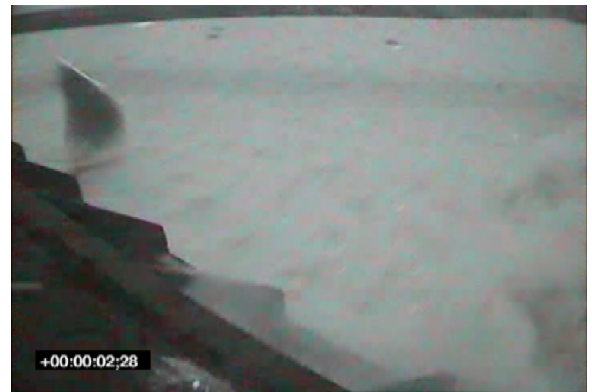
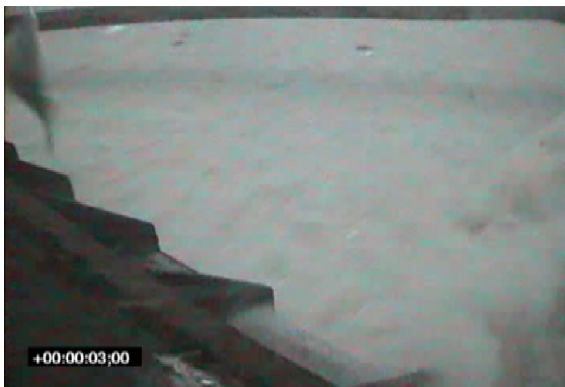
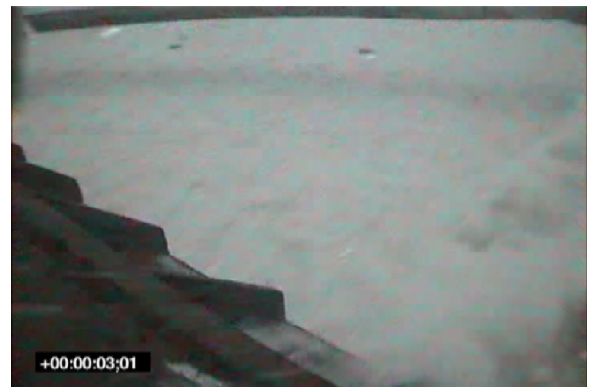
Figure 6: Sequence of shots showing a yellowtail escaping up and over a Cfarm excluder dredge.

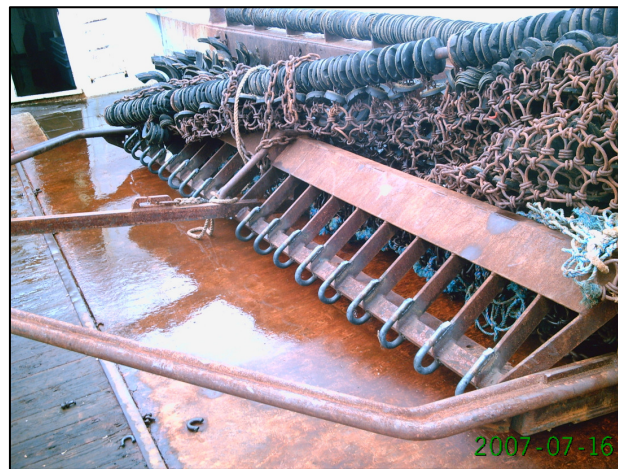
**Figure 1.** Experimental dredge design 3 with turtle guards on the cutting bar and a doubled outer bale.

Experimental Dredge Frame Design 3, as seen in Figures 1-7, was tested on trips Friendship 2007-4, and Friendship 2007-5. On the remaining trips the dredge was fished without any turtle guards attached to the cutting bar (Design 5).

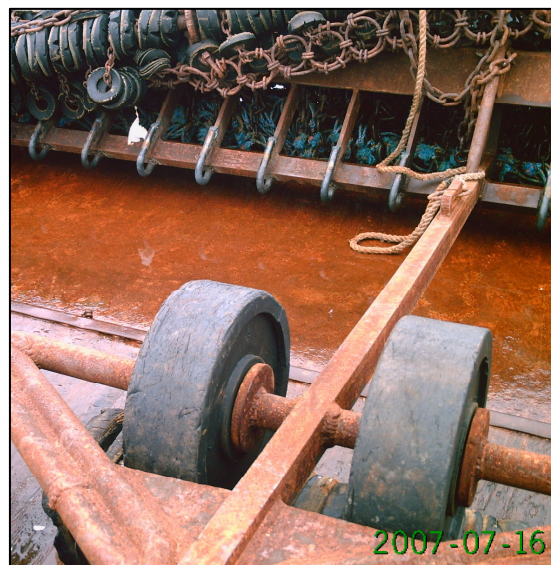
**Figure 2.** Wheels used on the experimental dredges had two molded 5"x 16" wheels with the axis positions 30" from top of the gooseneck.

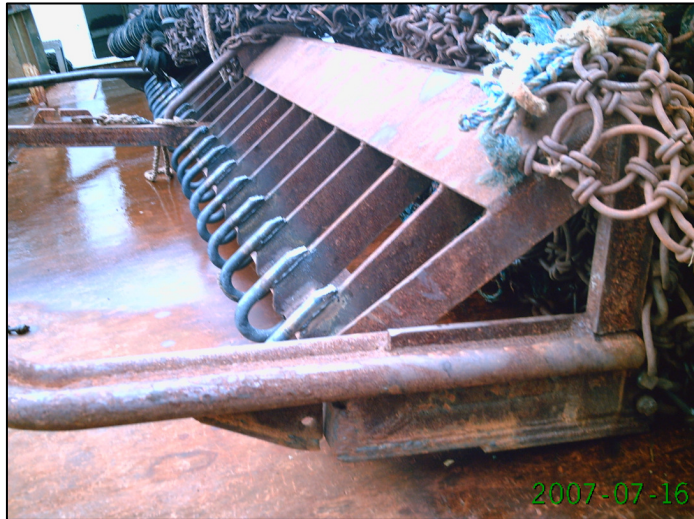
**Figure 3.** Side view of shoe used; the shoe was 1/2" x 3" spring steel cut 17 1/2" long and attached to 1 1/2" x 3 1/2" x 15" long bar stock

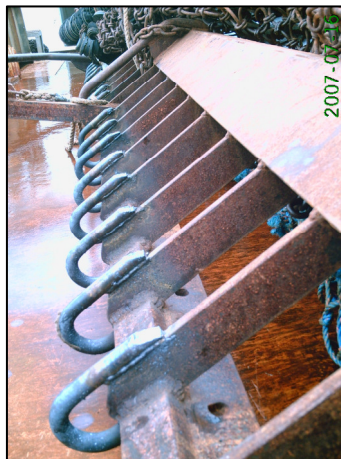
**Figure 4.** Space between struts measured 8 ½"; the spacing between the 8" depressor plate and cutting bar measure 10". The turtle guards were made of 1" hardened steel round stock and placed every 9" along struts

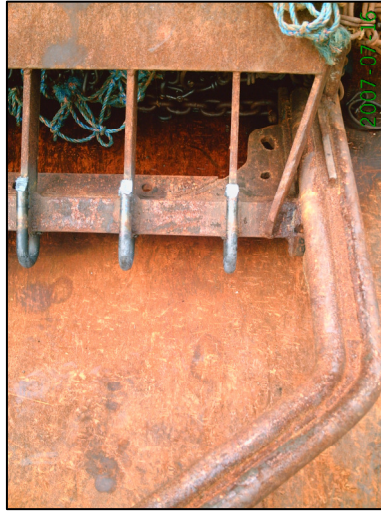
**Figure 5.** The bale extended forward 9 inches (interior measurement) before tapering to the tow point.
