## North American Journal of Fisheries Management

### Using Sea Turtle Carcasses to Assess the Conservation Potential of a Turtle Excluder Dredge

## Using Sea Turtle Carcasses to Assess the Conservation Potential of a Turtle Excluder Dredge

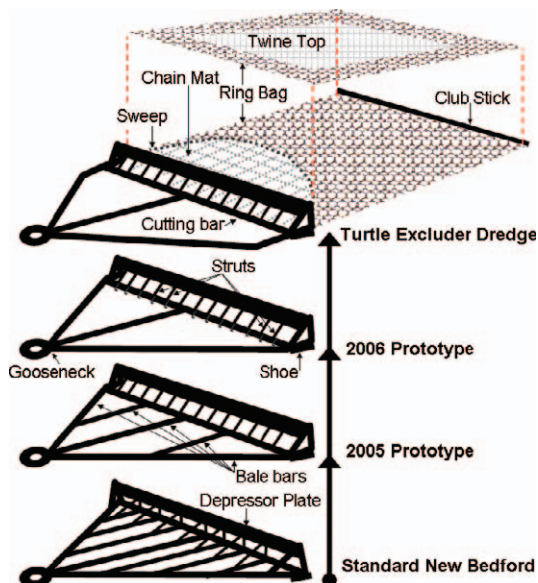
FIGURE 1.—Progression from the standard New Bedford dredge to the Cfarm turtle excluder dredge. All dredges pictured consist of a heavy steel bale welded to a rectangular frame. The bottom of the frame consists of a rectangular steel “cutting bar” that rests on steel shoes. Attached to the top of the frame is a forward-angled depressor plate. At the bottom of the frame, fastened to the shoes, is the sweep chain. The lower portion of the collecting net (called the ring bag) is attached to the sweep chain. The chain bag is fabricated out of welded steel rings and links. The top of the collecting bag consists of a twine top. A club stick is attached to the aft end of the net that holds the bag’s shape and facilitates dumping. Most vessels use dredges between 4 and 5 m wide.

The modified dredge was designed to reduce the likelihood of a sea turtle passing under the frame when it is fished along the sea floor. The new frame design is a significant departure from the New Bedford scallop dredge design because the cutting bar is moved forward of the depressor plate so that a sea turtle encounters a sloping (approximately 45°) rather than a vertical (approximately 90°) structure (Figure 1). The new

design utilizes a wide depressor plate (20 cm), and the struts are closely spaced (30-cm spacing) and extend between the depressor plate and the forward positioned cutting bar. In order to allow a sea turtle to escape upwards over the dredge, all modified dredges had fewer than the typical seven bale support bars, but the number of bars varied between prototypes.

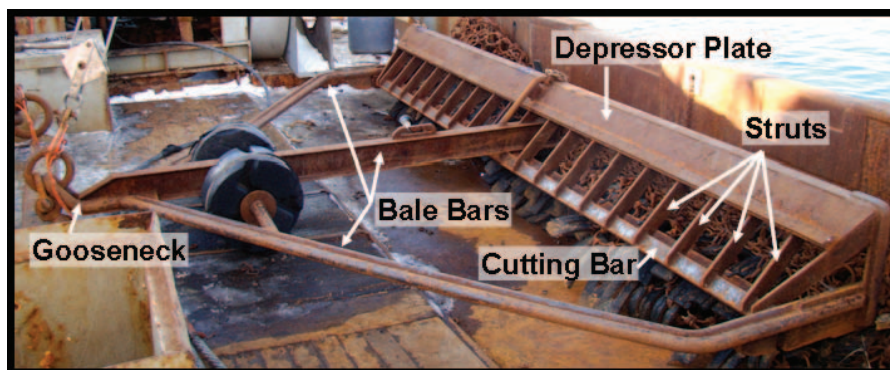
FIGURE 2.—Photograph of the Cfarm turtle excluder dredge.

After the 2006 loggerhead carcass tests, the prototype was further modified by removing the “turtle guards” from the cutting bar and extending the outside bale bar 50 cm from the main frame before they tapered toward the gooseneck (hauling point) to increase the escape opening between bale and frame. The result of this series of modifications is called the Cfarm turtle excluder dredge (Figure 2). Because the final Cfarm turtle excluder dredge design differed slightly from the 2006 prototype, additional carcass tests were per-

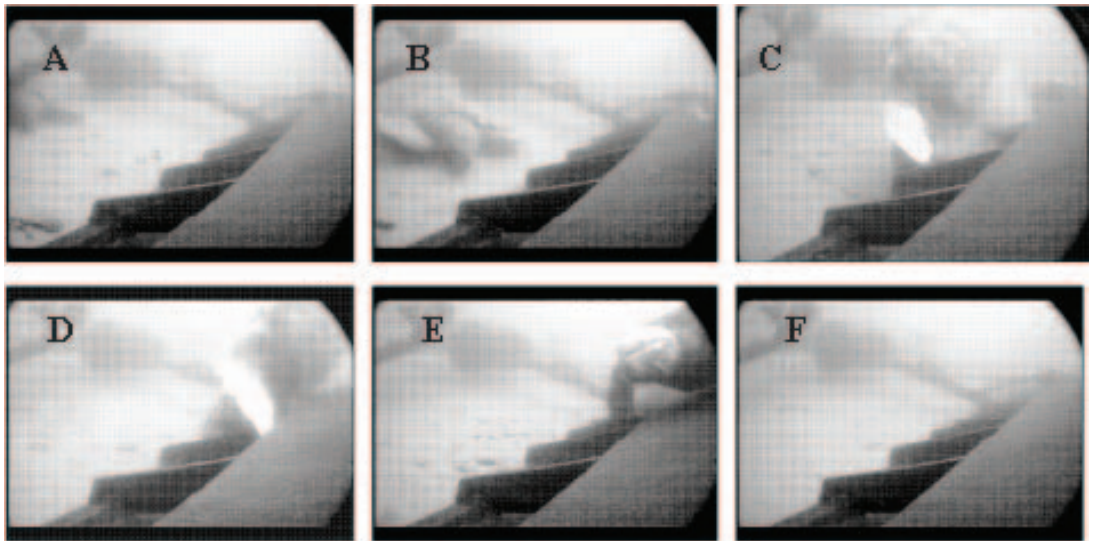
FIGURE 3.—Photographic sequence of a loggerhead sea turtle carcass encountering the Cfarm turtle excluder dredge: (A)–(B) the carcass first passes under the bale, then contacts the forward cutting bar, (C) gets deflected by the closely spaced struts, (D)–(E) is guided over the dredge frame, and (F) passes out of the view of the dredge-mounted video camera.

Nine interactions between a loggerhead carcass and the modified dredge were documented on the video recordings (Table 2; Figure 3). Two carcasses went over the dredge bale, while seven went underneath the bale. Two of the carcasses that went under the bale hit

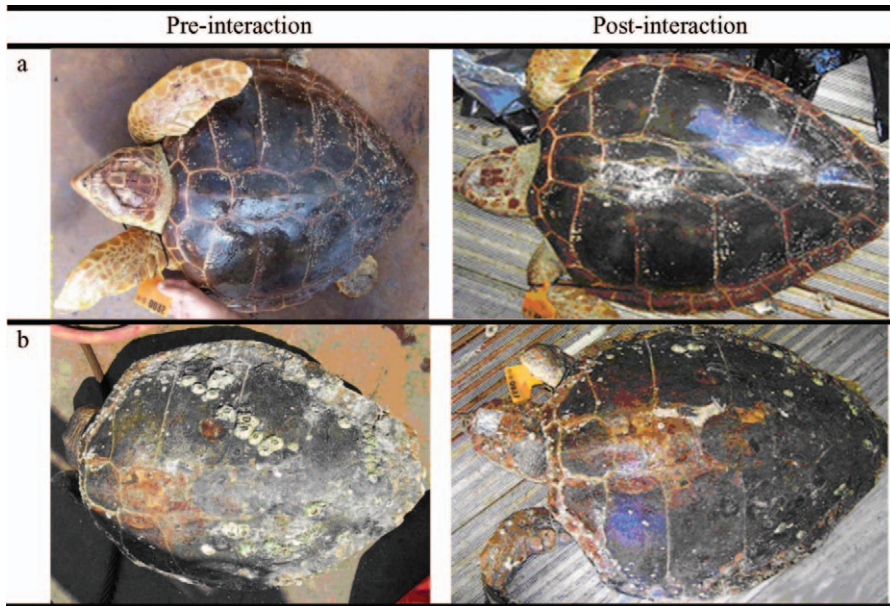
FIGURE 4.—Postinteraction carcass damage: (a) most loggerhead carcasses showed little or no damage after interacting with the turtle excluder dredge; (b) the most severe damage involved chips in the carapace scutes. Note that in both cases the damage to the head occurred during necropsy.

the hard rubber bale wheels and were hung up for a few seconds before passing the bale (one over and one under) and going over the dredge frame. In all nine interactions, the carcasses hit the dredge at some point and passed over the dredge frame. When all five carcasses were examined for injuries, the only observed carcass damage was superficial scratches and chips (Figure 4). None of the damage observed on the five recovered carcasses was consistent with a category I or category II injury (NMFS 2004).
